Discuss and take appropriate action concerning proposed change order from Workman Corporation concerning Parking Lot #2 repairs in the amount of \$23,500.00.

PROPOSED CHANGE ORDER
No. 00074

TITLE: *Parking Lot #2 Repairs*

PROJECT: Williamson County Regional Park

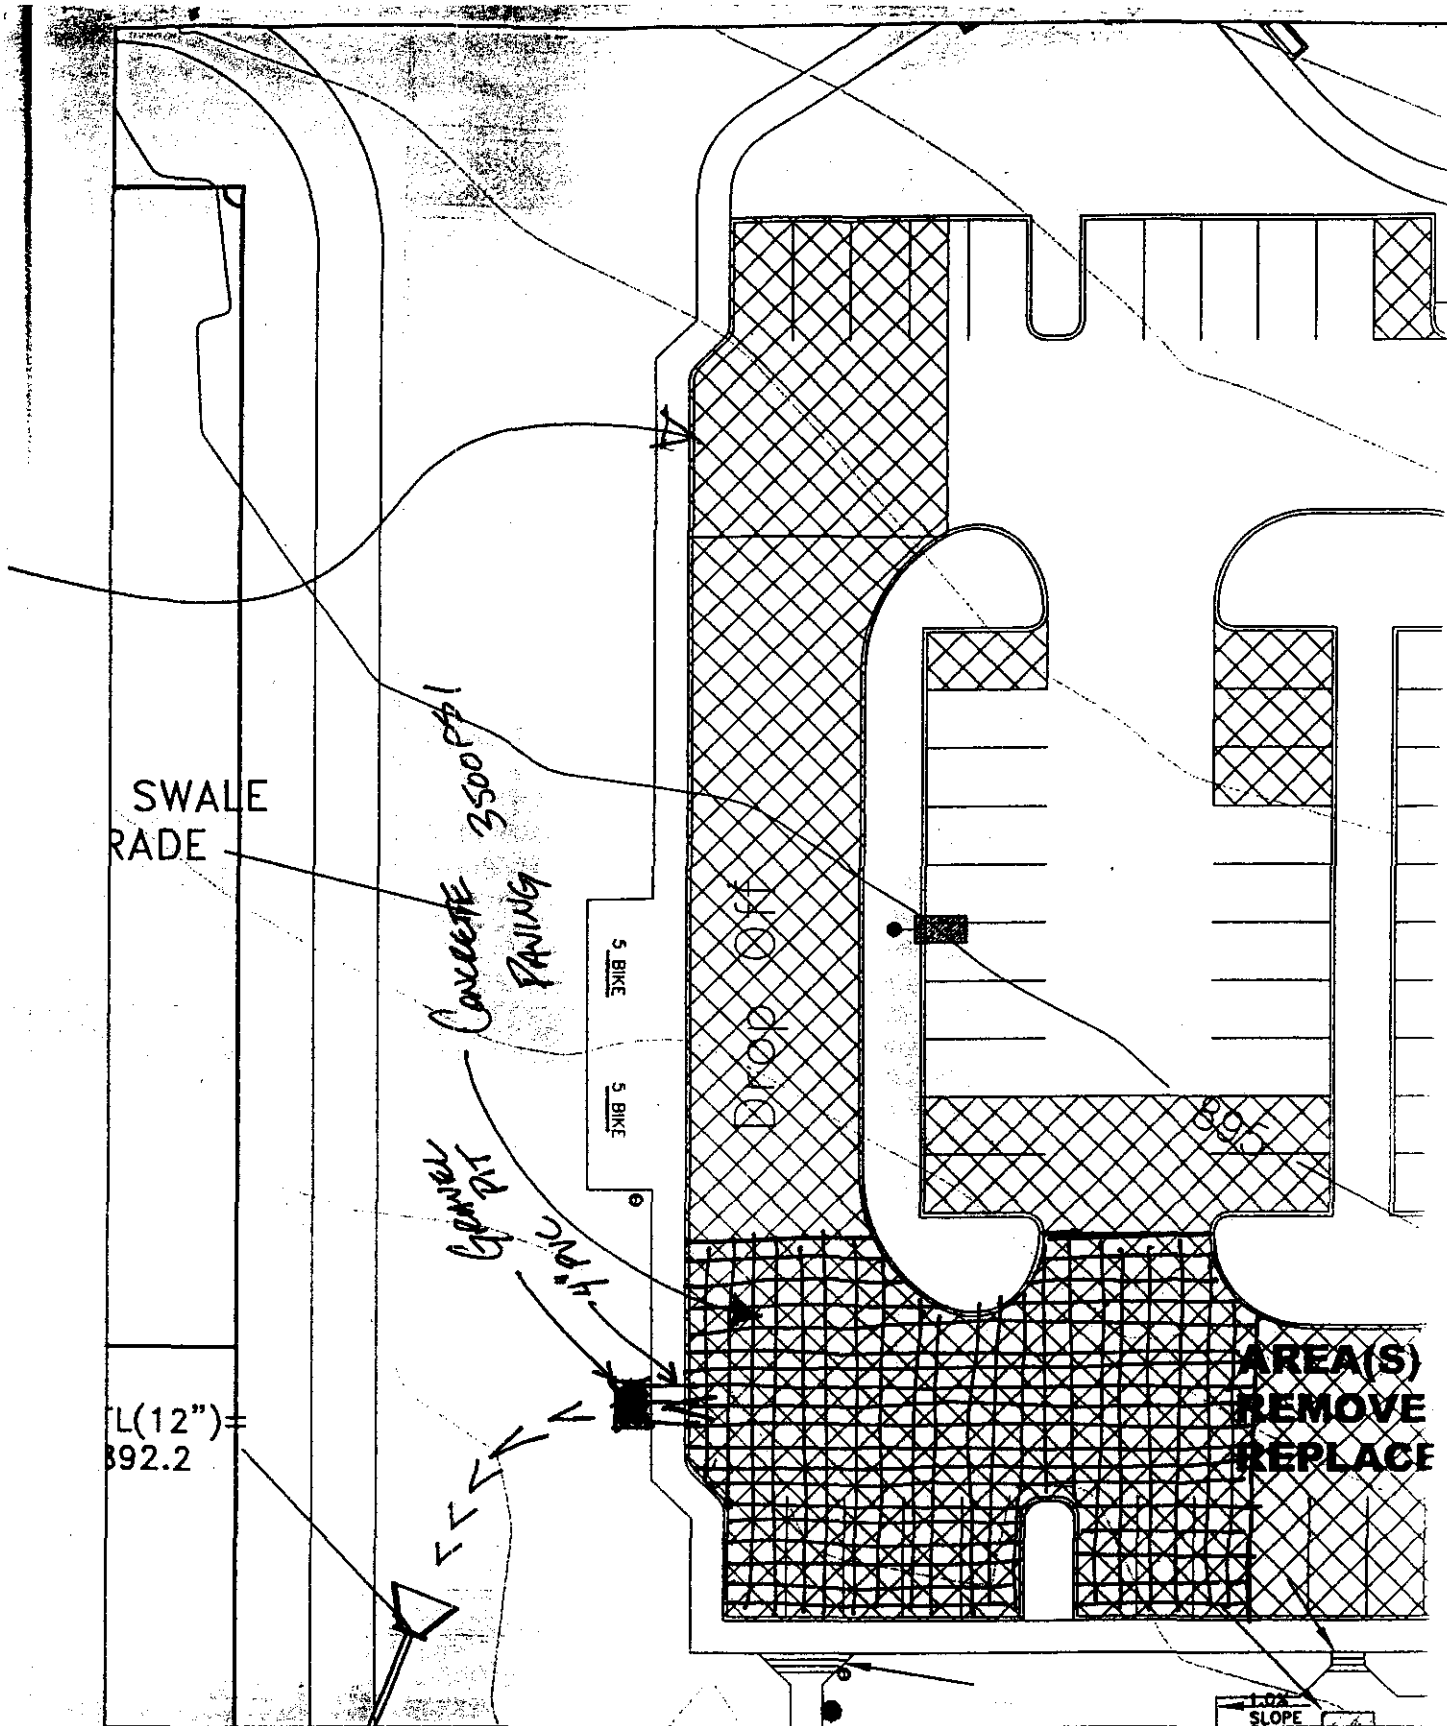
This change incorporates the additional work performed in Parking Lot #2 at the Williamson County Regional Park project. Sub-surface or groundwater was found to be in the general area of Parking Lot #2 after initial paving was constructed. This change includes the additional work to bridge this pre-existing condition. This change includes: all labor, material, equipment, supervision and incidentals to excavate the hotmix and flexible base in the failed areas, approximately 5400 square feet; install approximately 6" of 3/4"-1-1/2" washed river rock; #4 reinforcing bars on 16" O.C.E.W.; and 6" of concrete. Approximately 250 lineal feet of 4" perforated PVC pipe was installed on the north side of Parking Lot #2 to act as a french drain. Please see attached.

ALL OTHER AREAS TO BE RE-PAVED WITH HOT MIX (TYP)
